Manhole Inspection Summary

Manhole # S01WW1004MH

Location Address: **6216 Biltmore Ave** Cross Street: **W Strathmore Ave**

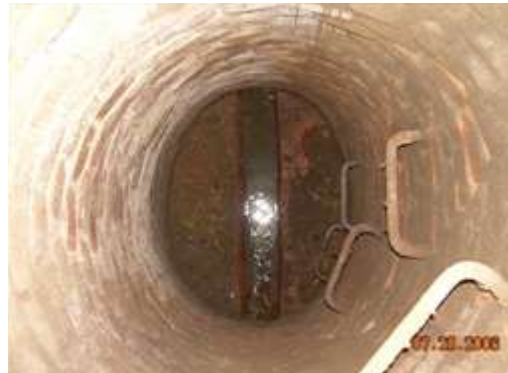
Top View

Chimney / Frame Adjustment ☒ Exists Material: **Brick** ☐ Parged Height: **3** (in.)
Condition: ☒ Sound ☐ Cracked ☐ Root Intrusion ☐ Loose Brick ☐ Deteriorated
Infiltration: ☐ None ☒ **Joint** ☐ Cracks ☐ Mortar ☐ Roots ☐ Wall

Barrel Material: **Brick** ☐ Parged
Shape: **Circular** Diameter: **42** (in.) Length: (in.)
Condition: ☒ Sound ☐ Cracked ☐ Root Intrusion ☐ Loose Brick ☐ Deteriorated
Infiltration: ☐ None ☐ Joint ☐ Cracks ☐ Mortar ☐ Roots ☒ **Wall**

Bench ☒ Exists Material: **Brick** ☐ Parged ☐ Debris (not Condition related)
Condition: ☐ Sound ☐ Cracked ☐ Root Intrusion ☐ Deteriorated ☐ Leaks ☒ **Debris**

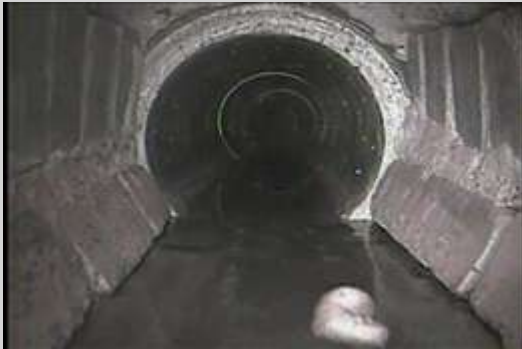
8 in. Circular Gravity Sewer Pipe Out @ 12 O'Clock

Pipe Material: **Clay** ☐ Pipe Lined

Invert Depth: **10.62** (ft.) Flow Characteristics: **Slow**

Deposits: ☒ None ☐ Mud ☐ Sludge ☐ Debris ☐ Grease

Infiltration: **None** Pipe Seal Cond: **Sound**

Drop: **None**

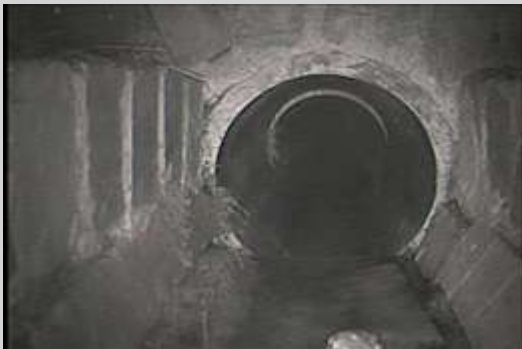
8 in. Circular Gravity Sewer Pipe In @ 6 O'Clock

Pipe Material: **Clay** ☐ Pipe Lined

Invert Depth: **10.53** (ft.) Flow Characteristics: **Slow**

Deposits: ☒ None ☐ Mud ☐ Sludge ☐ Debris ☐ Grease

Infiltration: **None** Pipe Seal Cond: **Sound**

Drop: **None**
